# Navajo Abandoned Uranium Mine

## Site Screen Report

**Mine Name: Golden Crown**  
**Mine ID: 245**

**Weston Solutions, Inc.**

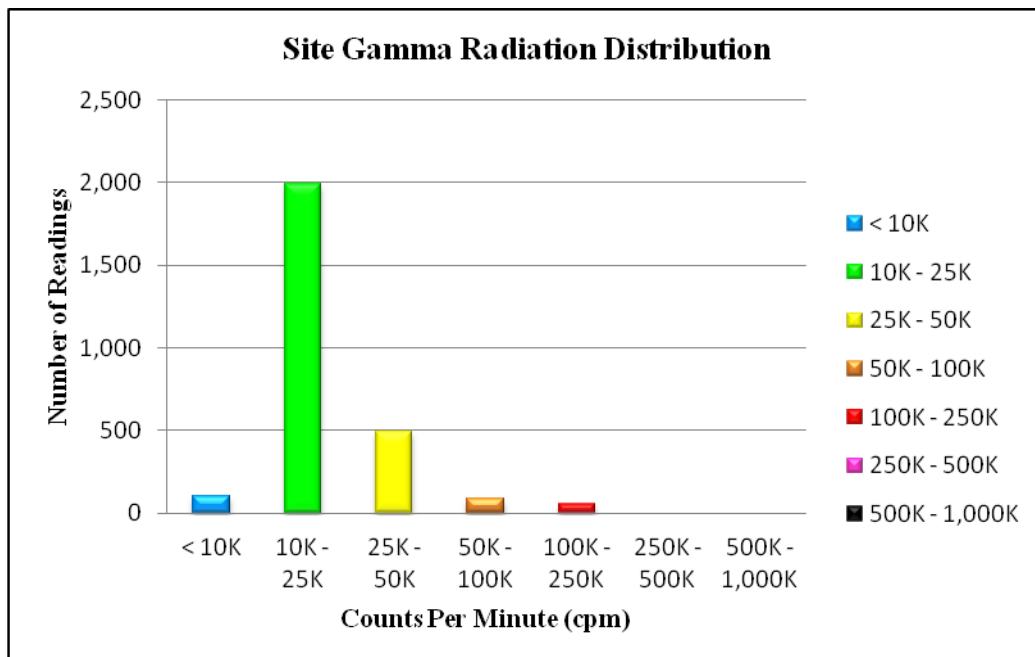
**Highest gamma radiation measurement:** 227,917 counts per minute (cpm)

**Background Average:** 13,177 cpm      **Two Times Background:** 26,354 cpm

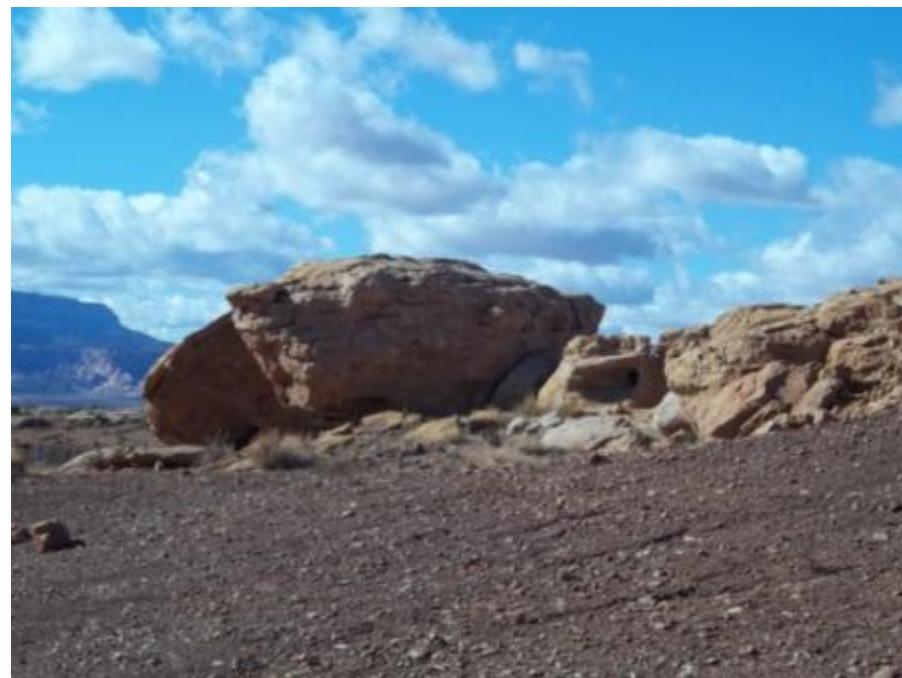
**Photo 2**

A total of 2,731 gamma radiation measurements were collected from the mine site, ranging from 6,159 cpm to 227,917 cpm. Maximum levels of approximately 50,000 cpm were found near the reclamation cap and 225,000 cpm were found near the yellow outcrop. The measurements are represented in Figures 1 and 2.

Mine Site #245 - Elevated gamma readings
